AAR - MAN LAN Core Node Hardware Upgrade ...

After Action Report

Network: MAN LAN

Issue Name: Core Node Hardware Upgrade

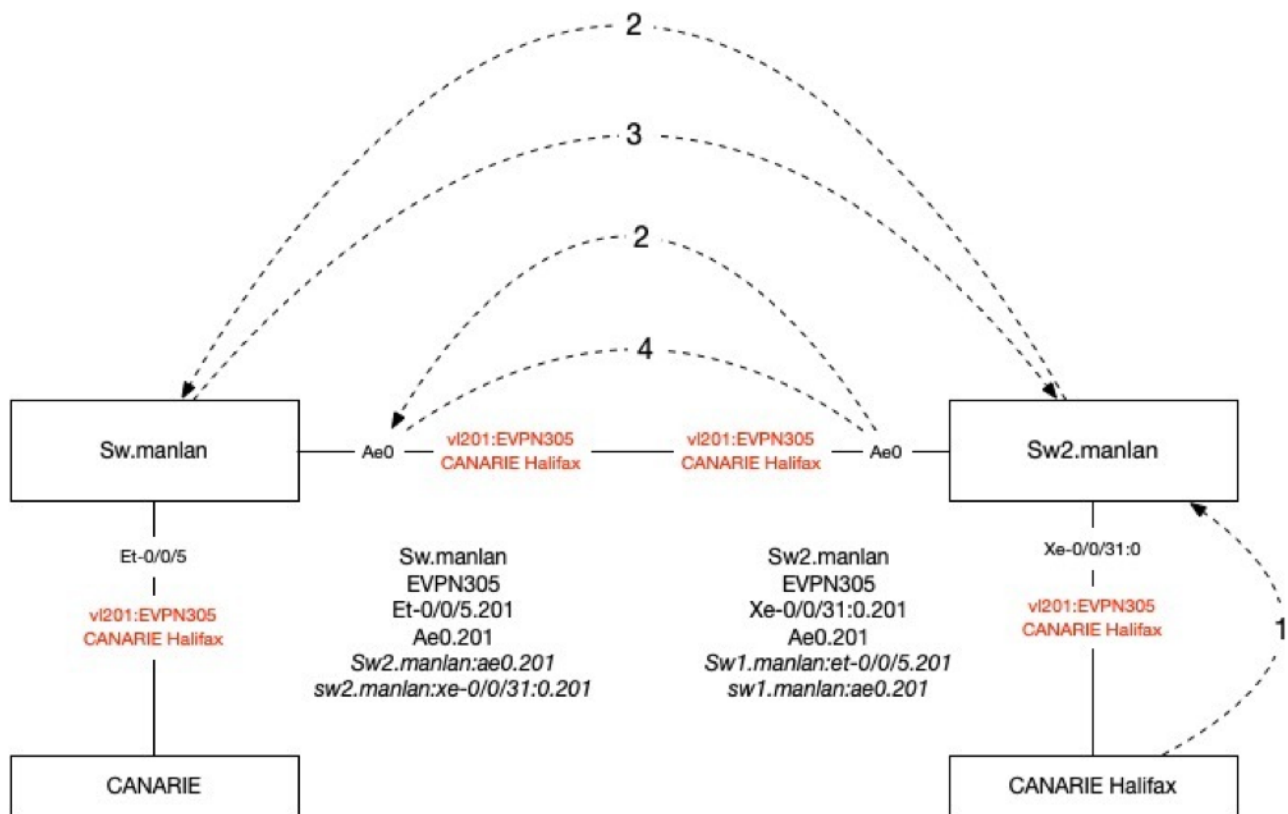
endpoints for the EVPN. This is unnecessary, since MAN LAN should have used VXLAN over the backbone interface to encapsulate EVPN traffic. However, due to a misconfiguration, ISIS was not functioning between the nodes, and as a result, VXLAN/Inter-node EVPN was not functioning correctly. Presumably, putting sw/sw2 interconnect VLANs in each VPN solved the issue by creating "manual" VLAN cross connects between the two nodes.

At 1014, engineering re-enabled the ISIS connection between sw.manlan and sw2.manlan, to match the original design. however, this effectively created a loop between the VLAN service interfaces. This is substantiated by time reported by CANARIE indicating performance issues at approximately 10:14AM EDT, 4 minutes after ISIS was enabled. The example below shows what likely occurred in the CANARIE case, however it's understood that this would have been an issue with any network that had ethernet services that spanned the two MAN LAN QFX10002 switches.

- 1.) Broadcast/Unknown Unicast/Multicast (BUM) traffic sent from CANARIE Halifax to sw2.manlan
- 2.) sw2.manlan sends traffic out all local ethernet segments as well as remote peers (sw.manlan) via VXLAN
- 3.) sw.manlan receives traffic via ae0.201 and replicates traffic out all ethernet segments except for ae0.201 (split horizon) but does send it back to the remote peer on sw2.manlan via VXLAN.

sw.manlan also receives traffic via VXLAN and replicates it back via ae0.201 to sw2.manlan.

4.) sw2.manlan receives traffic via vxlan, as well as ae0.201, loop is complete
